**Flood Control Project Maintenance  
Levee Inspections****LMA District Cover Sheet****Spring 2013 Levee Inspection Results****Marysville Levee Commission**

**Levee Inspection Report By Mile - Spring 2013**

**Marysville Levee Commission**

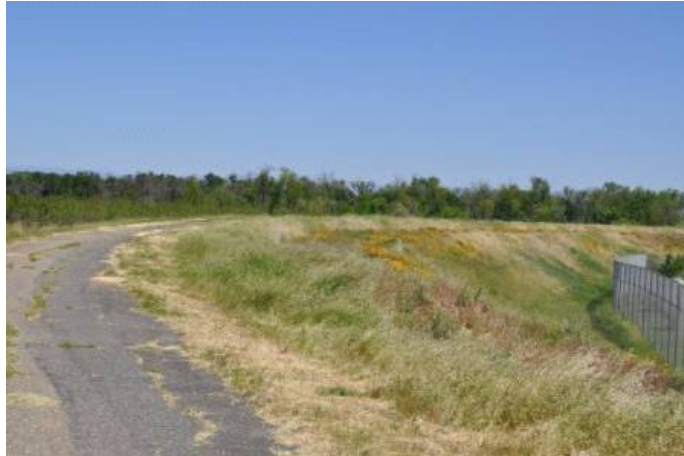
Levee Mile Report Line	4
Start Levee Mile	0.00
End Levee Mile	3.25
Location	Land Side
Category	
Item	Vegetation
Marysville, Unit 1 -Typical L/S slope vegetation.	
rburnett_s_20130417_230.JPG

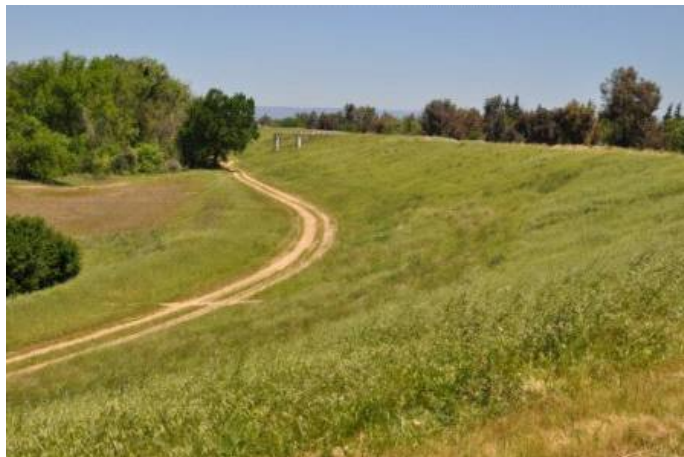
Levee Mile Report Line	5
Start Levee Mile	0.00
End Levee Mile	3.25
Location	Water Side
Category	
Item	Vegetation
Marysville, Unit 1 -Typical W/S slope vegetation.	
rburnett_s_20130417_231.JPG

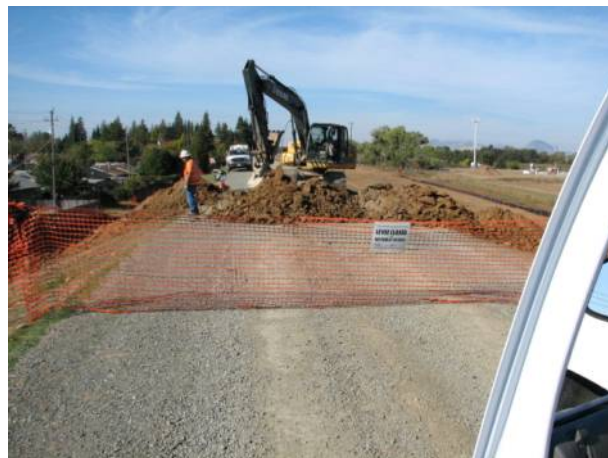
Levee Mile Report Line	6
Start Levee Mile	1.17
End Levee Mile	2.46
Location	Crown
Category	
Item	Encroachments
Levee repair work on process.	
jhirabay_s_20130314_029.JPG

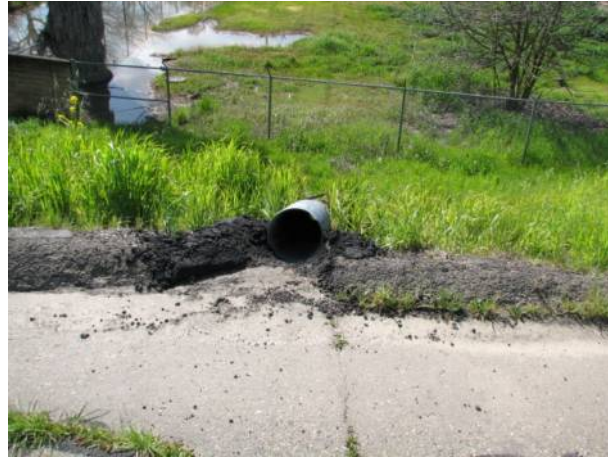
Levee Mile Report Line	7
Start Levee Mile	3.21
End Levee Mile	3.21
Location	Land Side
Category	
Item	Slope Stability
This site is on the Corps PI.	
jhirabay_s_20130314_028.jpg

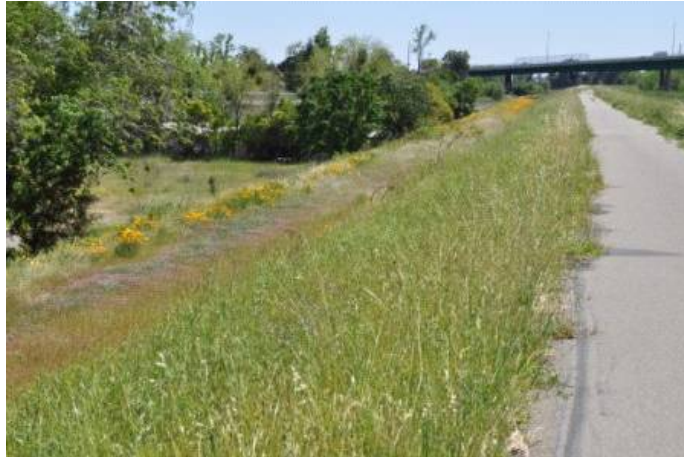
Levee Mile Report Line	1
Start Levee Mile	0.02
End Levee Mile	1.26
Location	Land Side
Category	
Item	Vegetation
Marysville, Unit 2 -Typical L/S slope vegetation.	
rburnett_s_20130417_232.JPG

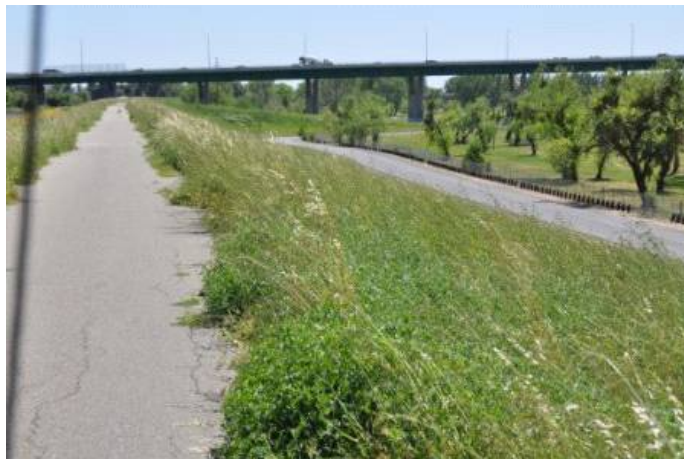
Levee Mile Report Line	2
Start Levee Mile	0.02
End Levee Mile	1.26
Location	Water Side
Category	
Item	Vegetation
Marysville, Unit 2 -Typical W/S slope vegetation	
rburnett_s_20130417_233.JPG

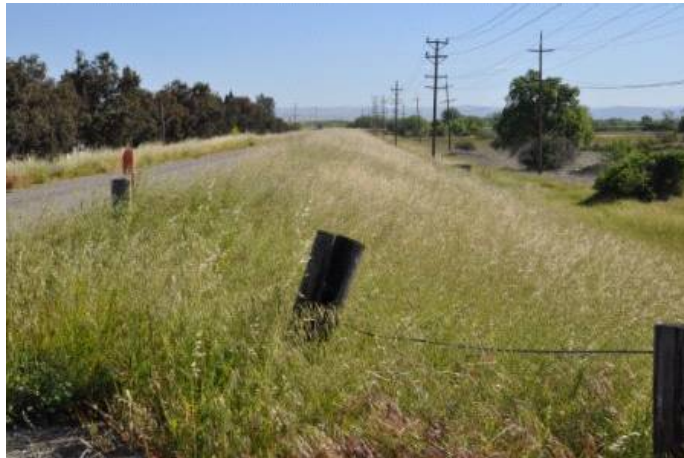
Levee Mile Report Line	1
Start Levee Mile	0.14
End Levee Mile	4.88
Location	Water Side
Category	
Item	Vegetation

Marysville, Unit 3 - Typical W/S seasonal vegetation.

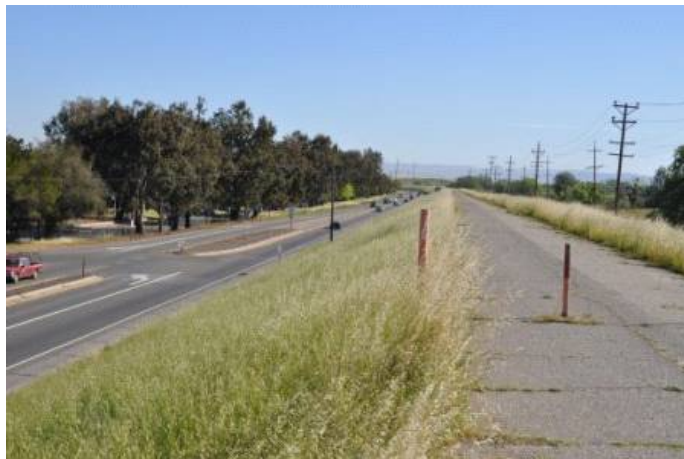
Levee Mile Report Line	2
Start Levee Mile	0.14
End Levee Mile	4.88
Location	Land Side
Category	
Item	Vegetation

Marysville, Unit 3 - Typical L/S seasonal vegetation.

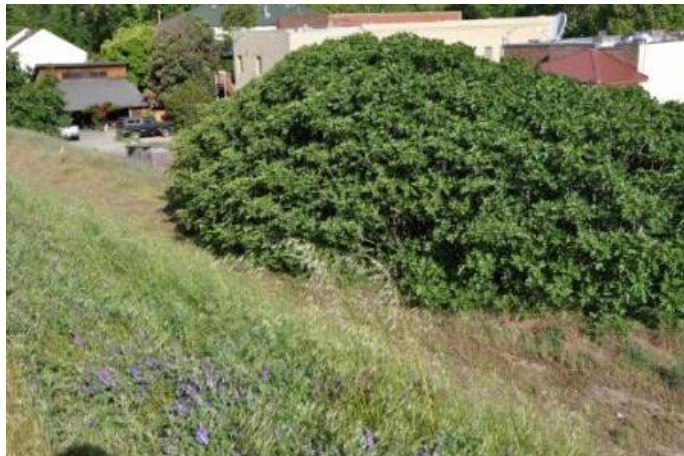
Levee Mile Report Line	4
Start Levee Mile	0.39
End Levee Mile	0.39
Location	Land Side
Category	
Item	Trim / Thin Trees

Marysville, Unit 3 - Fig tree at lower section of levee.

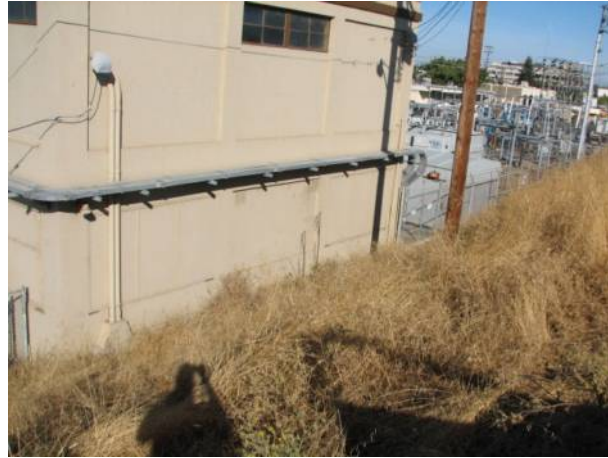
Levee Mile Report Line	5
Start Levee Mile	0.86
End Levee Mile	0.86
Location	Land Side
Category	
Item	Encroachments
Building encroaching at landside levee toe.	
jhirabay_s_20130314_030.jpg

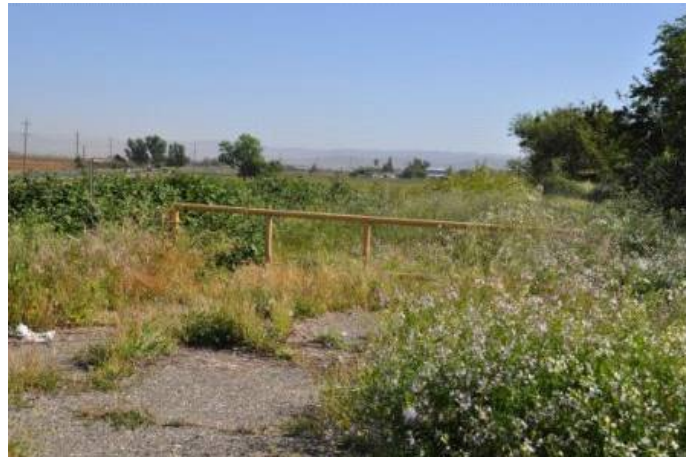
Levee Mile Report Line	6
Start Levee Mile	4.88
End Levee Mile	6.79
Location	Crown
Category	
Item	Encroachments
Marysville, Unit 3 - Spring 2013 - Patrol road vegetation.	
rburnett_s_20130418_238.JPG

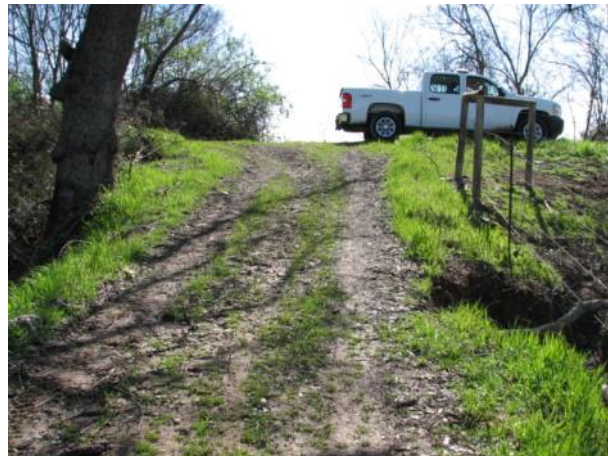
Levee Mile Report Line	7
Start Levee Mile	5.54
End Levee Mile	5.54
Location	Crown
Category	
Item	Encroachments
This ramp is on the patrol road, no known permit.	
jhirabay_s_20130314_032.jpg
